UNITED STATES DISTRICT COURT EASTERN DISTRICT OF MISSOURI **EASTERN DIVISION**

Case No. 4:20-cv-0135 VS.

COMPLAINT

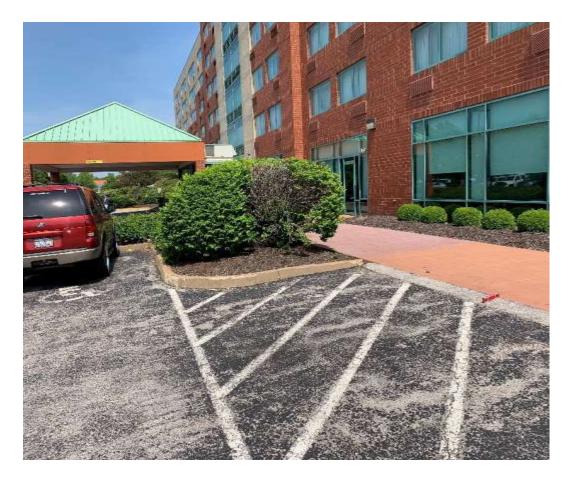
- e. (i) The running slope of the transition from the access aisle to the walking surface shown in the photograph below is steeper than 1:12. (ii) The running slope of the transition from the access aisle to the walking surface shown in the photograph below is steeper than 1:12 and steeper than 13%, in violation of Federal Law 2010, ADAAG § 405.2. (iii) While moving in his wheelchair, the Plaintiff encountered this steep slope and he required assistance to move over it. (iv) The action required to reduce the slope of the transition from the access aisle to the walking surface is easily accomplishable and able to be carried out without much difficulty or expense.
